EXETER CITY COUNCIL

PLANNING COMMITTEE 20 FEBRUARY 2012

BUILDINGS AT RISK

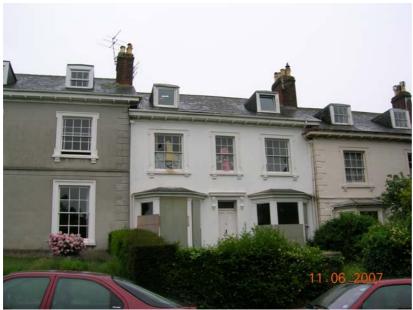
Exterior after squatters had damaged the building in 2007

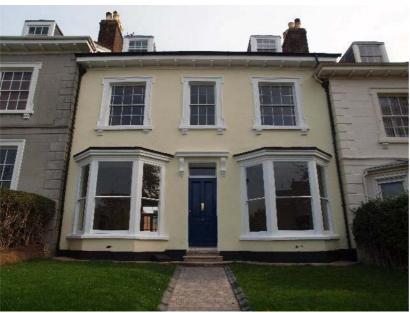
Exterior today

The restoration works have been completed and the Enforcement Notice complied with. The building has been completely renovated using traditional lath and plaster internal walls, with thermal upgrading using sheep wool insulation.

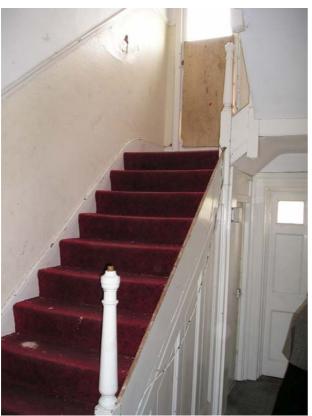
Hallway showing extensive damage to staircase

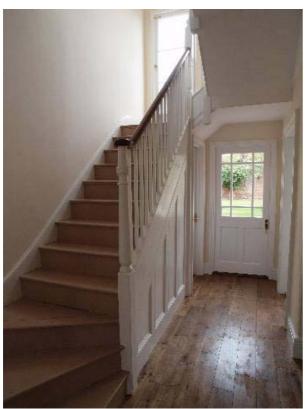
Rebuilt staircase

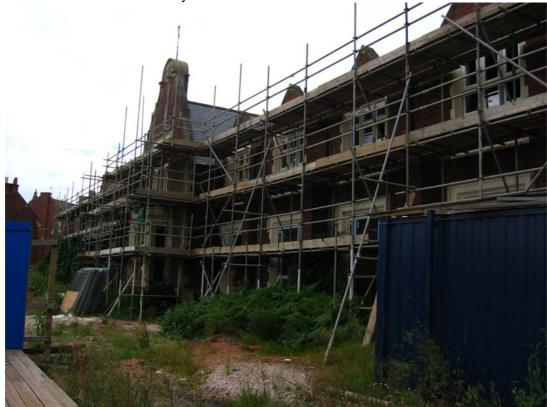
In 2010, with conversion abandoned and the developers in administration.

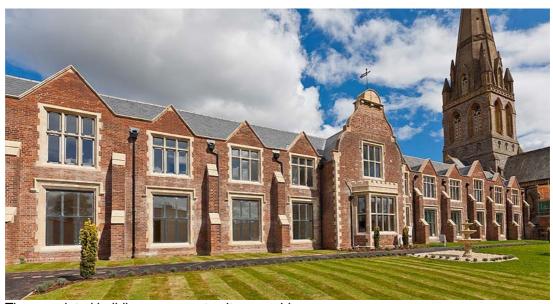
The completed building now, most units are sold.

The restoration of these properties has now been completed and they are being marketed as "The Discovery Quarter".

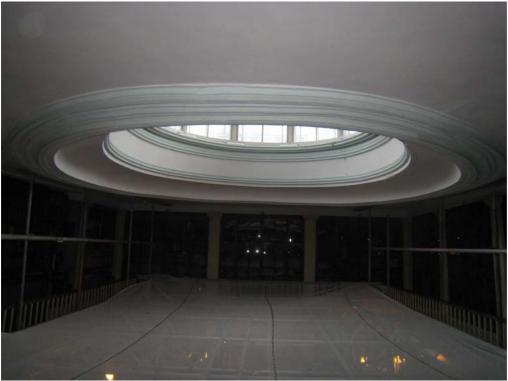
The roof of 7 Cathedral Close contains two fine domed lanterns that light the library spaces. Water ingress around the domes led to an inspection by a specialist architect and an English Heritage structural surveyor. They found that the long span beams that support the domes are undersized. In addition, the roof covering was changed in 1994 from copper to lead, which has added extra weight and stress and this has been exacerbated by the heavy snow loading over the past couple of winters. This has lead to the beams splitting and has caused the structures to move, dropping into the building by approximately 5 inches.

The dome is dropping into the library. The structure is currently supported by scaffolding, with netting to catch any falling debris.

The alterations required to prevent collapse of the domes include strengthening the existing beams with steel supports and further investigation will require the lead roof covering to be removed.
