Comprehensive Vehicle Inspection Report

Report No: 9762

Make TOYOTA

Model AVENSIS TR D-4D

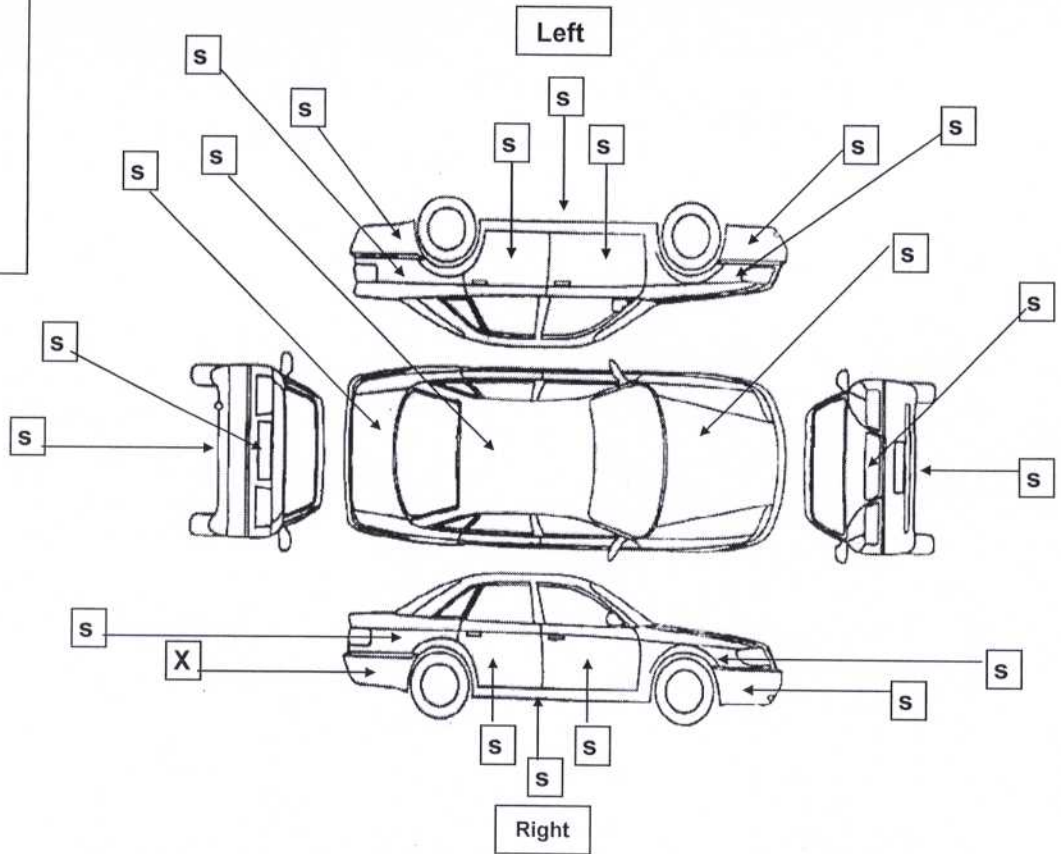
- S satisfactory
- R repainted
- = scratch
- X dent
- O corrosion
- C chip / rust
- P previous repairs

The exterior body condition was good and commensurate with the vehicles age and recorded mileage.

Item	Comment
5	Damage to rear bumper right hand corner.
