# Comprehensive Vehicle Inspection Report

Report No: 9765

Make TOYOTA

Model PRIUS T SPIRIT VVT-I

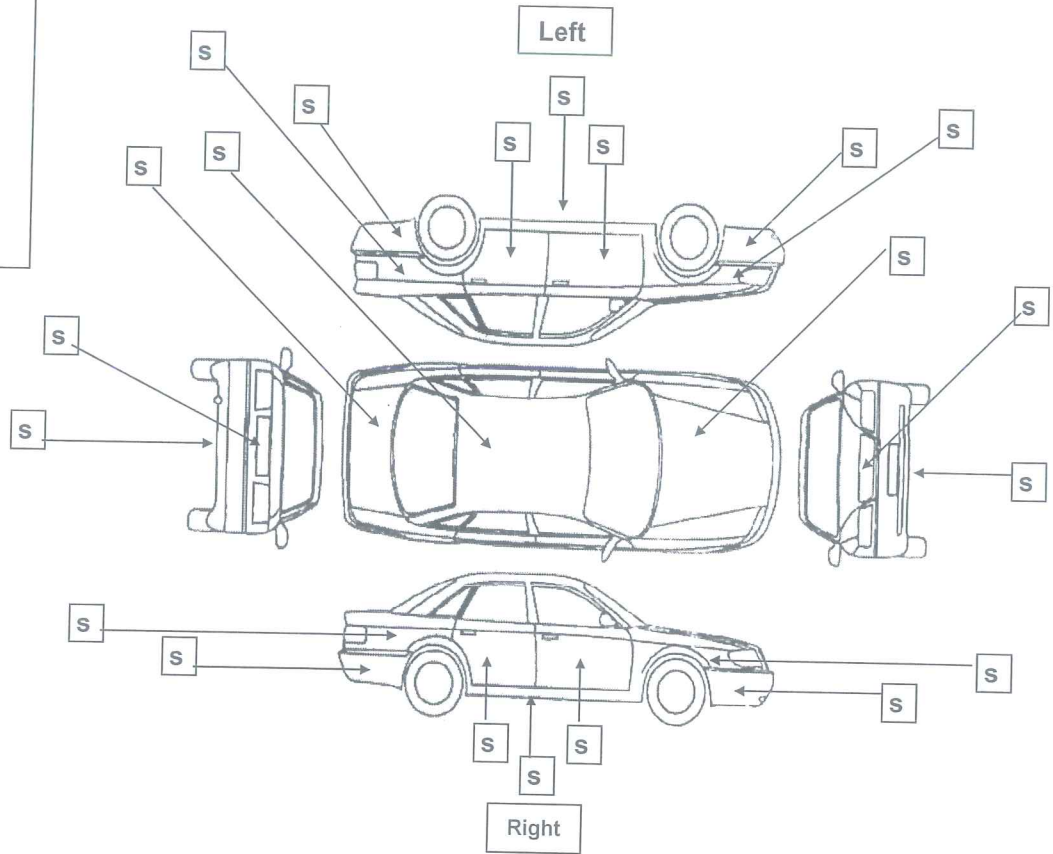
**EVIDENCE OF BODYWORK REPAIRS**      Yes X      No  
**BODYWORK CLEAN AND DRY**              Yes X      No (See Notes)

The exterior body condition was good and commensurate with the vehicles age and recorded mileage.
