### Comprehensive Vehicle Inspection Report

**Report No:** 10136

**Make** VOLKSWAGEN

**Model** CADDY MAXI LIFE TDI

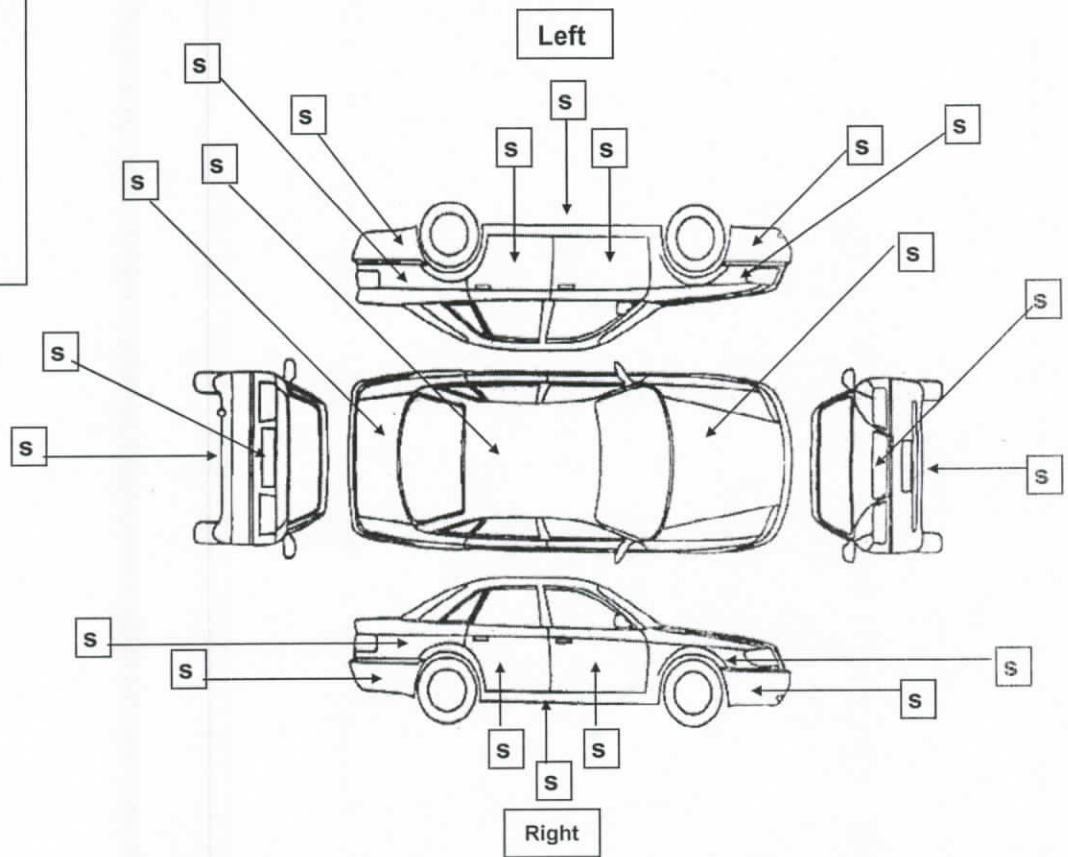
The exterior body condition was good and commensurate with the vehicles age and recorded mileage.
