VEHICLE EXAMINATION REPORT

Report No: NL/20170004	Inspection Date: 2 June 2017
Customer Details Mr. N. Bibby The Flats 78 Fore Street Heavitree Exeter EX1 2RR	Inspection Address Home Address
Telephone: 01392 498651 or 07580 203599	Telephone:

Make & Model	Volkswagen Transporter T30 TDi	Registration No.	SH56 FOC
Colour	White	Engine CC	1896 (approx)
Vehicle Identity Number. (VIN No.)	WV2ZZZ7HZ6X019519	Confirmed	Yes
Engine No.: AXB 119 541 Not seen on the engine block NOTE: Engine Capacity cannot be confirmed			
V5 Registration doc checked	YES	MOT Certificate Expires	04/05/2018
Odometer Reading	121162 Miles	Service Records Seen	No

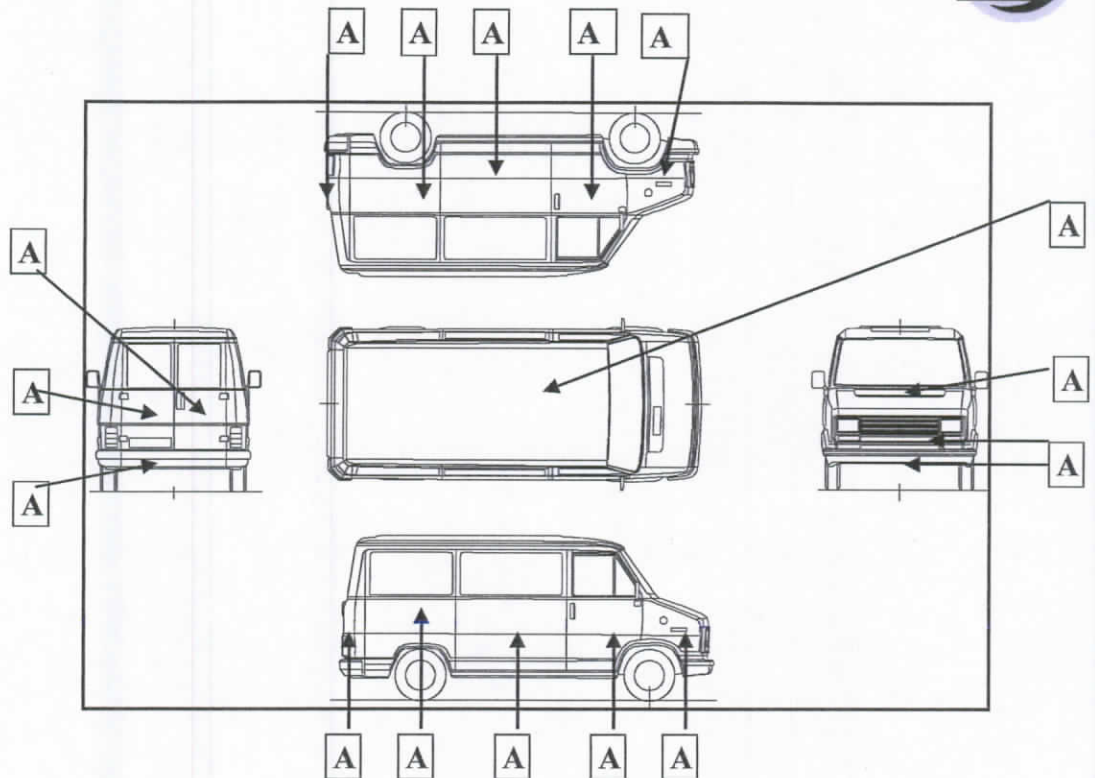
EXTERIOR PANELS

There were some marks etc., noted to aaround the vehicle, some of which may polish out. There was a dent noted in the R/H sill panel (under the sliding door) and another (with scratches) was in the front area of the L/H/R wheel arch area, however, these were not considered detrimental to the overall condition bearing in mind its age and mileage..
