Habitat Regulations Executive Committee

Appendix B: Pebblebed Heaths Trail Audit - Summary Results

SUMMARY REPORT FROM TRAIL AUDIT 2017

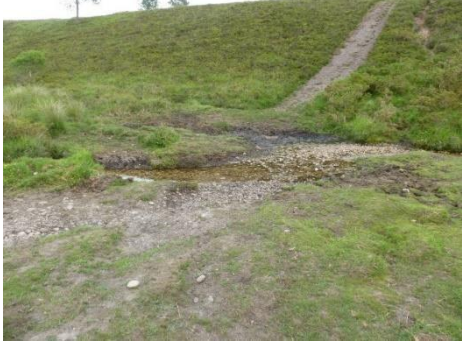
Common	ID	Con	Problem and recommendations		Action
Bicton	B8e	A	<p>At GR 0391 8600 the stream has broken its banks and splits in two making an awkward and muddy crossing. Two Sleeper type footbridges required, constructed to give a deck width of 500mm minimum, protected by heavy duty netting to give non-slip surface. No handrail required as long as the height of the deck above the stream bed is no more than 750mm. Heavy duty netting to be fixed to the deck to give non-slip surface. The bridge on the western side needs to be 4 metre span, the eastern one 5 metres. Abutments suggested as 1 metre lengths of the same timber (cross-section 255 x 90mm), set into the ground with the deck timber firmly fixed.</p>

<p>10m boardwalk, required?</p>
Bicton	B10b	A	<p>At the northern end at GR 0369 8625 the sleeper walkway across the muddy stream. Replace with a similar type structure, overall length 15 metres, minimum width 500mm plus, covered with heavy duty netting for non-slip surface.</p>

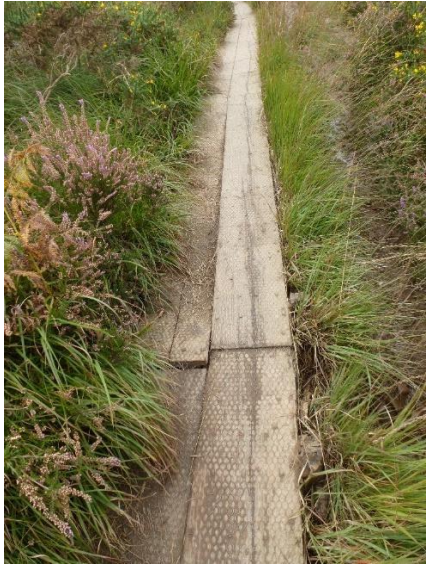
Colaton Raleigh	CR1d	A	<p>ADVISORY: Steps at GR 0471 8707 [Photos CR1d 3&4]. The stone infill and some of the timber risers have become eroded. The steps run along the NW side of the path, are overgrown, and do not appear to be used. Query as to whether repair/rebuild is justified. The remaining steps could either be removed, or left as they are.</p> <p>WATCH: Sleeper bridge at GR 0462 8701 [Photos CR1d 6&7]. The structure is currently sound and stable, although this is not apparent in the photos. No action at present, but watch for future deterioration.</p> <p>ATTENTION: Sleeper walkway. GR 0461 8700 [Photo CR1d 8]. An awkward step onto the walkway at the NE end from the steep, muddy path surface. Improve access by the construction of two or three steps, timber risers infilled with stone. Materials: Timber, c 255 x 130mm section, total length 4 metres to make three steps. Approx. 1.5T stone for infill. GR 0456 8695 [Photo CR1d. 10] One of the surface timbers is breaking up and collapsing. Replace with treated timber, 130 x 255 x 2400mm. The whole 130m length of the walkway has been covered with lightweight wire netting to provide a non-slip surface. This is no longer fit for purpose, having been worn away, also presenting a potential trip hazard. Should be replaced by heavy gauge welded galvanised netting (130 x 0.50 metre width)</p>

<p>Remove old steps. Install 3 steps. Replace rotten board. Netting for 130m board.</p>

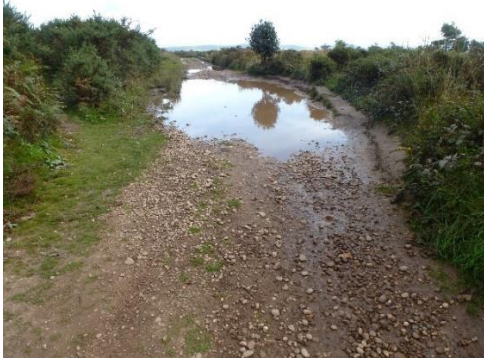
Colaton Raleigh	CR2a	A	<p>ATTENTION:GR 0422 8800 to 0450 8807 For the first approx. 230 metres the path is subject to flooding. Surface water collects where the track is lower than the surrounding ground and no run-off is possible [Photos 1 to 6] (alternative narrow tracks have been created by walkers on the north side of the main track).The remaining 270 metres has minor ponding at locations shown [Photos 7 to 9].The flooding can be remedied by laying stone, and compacting to form a crown which will allow the track to drain. This is estimated to require 200T+ of stone, suggested quantities for each location shown in the photo titles.</p>

<p>Reduce to 80T and address drainage.</p>

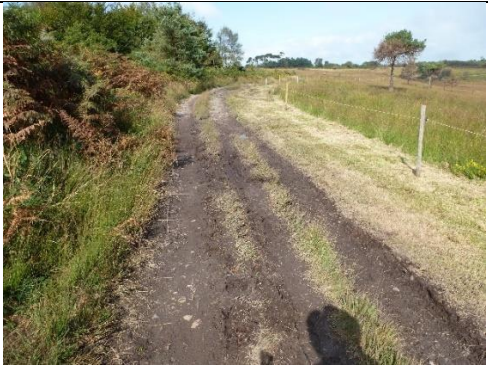
Colaton Raleigh	CR3a	A	<p>Between GRs 0339 8746 & 0336 8757 [Photos 3 to 6] 130 metres with deep ruts, mud and standing water in wet weather. Approx 50T stone to infill ruts, laid to form a crown, and compacted.</p>

<p>130m 40T as dug Heath brash</p>
Colaton Raleigh	CR3c	A	<p>ATTENTION: Sleeper walkway at GR 0341 8775 [Photos 1&2] Low point in the track. The track is prone to flooding and accumulation of mud for about 20 metres, and the existing sleeper walkway on the West side is in disrepair</p> <p>Two suggested remedies: a) Rebuild the walkway Treated timber sized 130 x 255 x 2400mm, double width, to replace existing walkway. To construct the deck, 18 such timbers required. To create footings, 6 extra required, to be cut to 800mm length to support each end of the decking sections. The whole to be covered on the upper surface with heavy gauge welded galvanised netting.</p> <p>b) Raise the level of the track. 30T stone laid to form a crown to assist drainage, and to provide 2 metre width for vehicular use.</p> <p>WATCH GR 0342 8778 [Photo 3]. At the junction with CR4b the track is lower on the southern side, allowing a build-up of mud. Passable for walkers at present. Could be resolved by raising track level with c5T stone.</p>

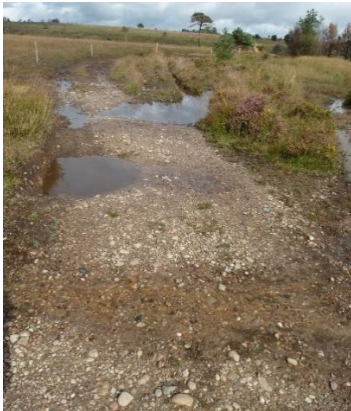
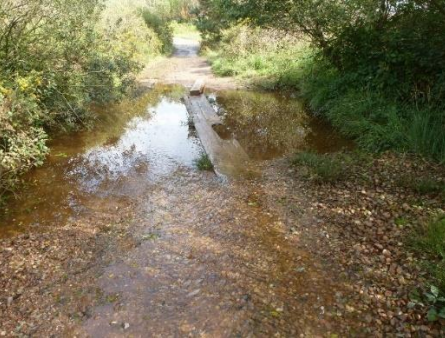
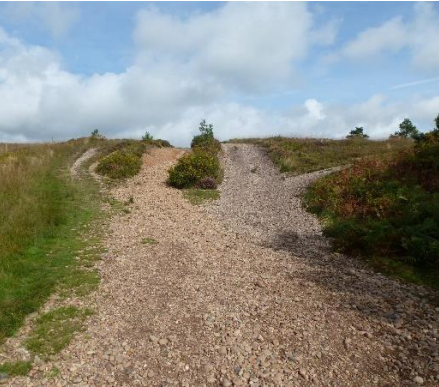
Colaton Raleigh	CR6a	A	<p>ATTENTION: Muddy and flooded section GR 0375 8740 [Photos 2 to 6] Path enters left-right-left S bend. Confused section with surface water and build-up of mud. No evidence of significant water action causing wash-out, so building up the track base should restore the track. 50T stone laid and built up to create a crown profile, 3 metre width to give good vehicular and recreational access.</p> <p>WATCH: Surface water from GR 0377 8743 to 0383 8748, a 65 metre level section covered by slow-moving surface water to a maximum depth of 20 to 30 mm. Currently this is negotiable for path users, and no apparent risk of erosion.</p> <p>ATTENTION: Flooded section from GR 0384 8751 to 0369 8754 [Photos 10 to 12]. The track descends to run level to the south east a large pond. The track is covered by shallow, slow-moving water for approx. 30 metres, before reaching a water course crossing the track from the pond, with an inadequate sleeper bridge to provide a crossing point. Two suggested remedies: a) Replace the existing bridge with a longer, 9 metre, structure, sited at the SE side of the track to allow access for vehicles. Some cutting of overhanging trees and bushes will be needed to create headroom. Bridge construction: treated timber sized 130 x 255 x 2400mm, double width. 10 timbers in all, 8 for the deck, and the other two to be cut to 800mm lengths to construct the footings. All to be covered with heavy gauge welded galvanised netting. b) Alternatively it may be possible to create a route for walkers around the northern side of the pond [Photo 13]. There are no significant water courses entering the pond across this route. Clearing of undergrowth and levelling of the surface to produce a walking surface.</p> <p>WATCH GR 0393 8759 [Photos 14&15]. The track rises sharply towards the North East, the central section is badly eroded on the slope. Alternative routes on either side, the eastern option is in good condition and the preferred option for walkers and vehicles. Block eroded routes to discourage use.</p>

<p>Reduce width so reduce stone 20T 40mm 20T as dug 9m boardwalk Heath brash</p>

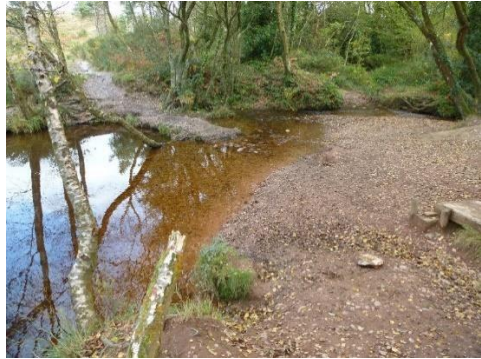
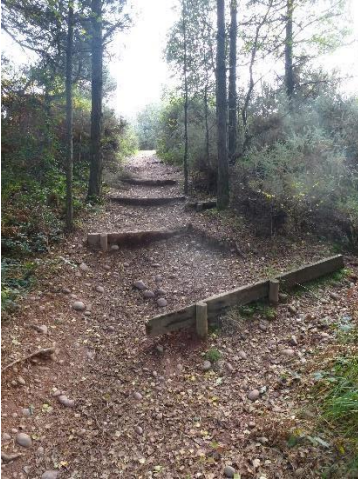
Colaton Raleigh	CR10b	A	<p>ATTENTION: GR 0508 8688. A stream crosses the route, but in wet weather ponding spreads over a greater area (approx. 5 metres in width). A previous sleeper bridge has collapsed. Suggested remedy: Install two sleeper type bridges, [as indicated in Photo CR10b Bridge site]. At the southern end the remains of the footings for the previous bridge(s) are in place and still sound. New footings for the main bridge [shown as "1" in the bridge site photo] will be sited next to this, and the existing structure can act as a step onto the new bridge. This position will occasionally flood, therefore the suggestion is that a concrete plinth should be formed. Excavate a 900mm square hole, approx. 200mm deep, construct temporary wooden formers and fill with approx. 0.5 cu m concrete. The top surface will then be approx. 300mm above ground level. Before the concrete sets steel bolts or rods inserted to project 400mm vertically will provide anchorage points for the timber decking. Footings 2 & 3 can be constructed from 800mm lengths of treated timber, 150 x 300mm section. Bridge decking timbers to be 150 x 300mm section, laid as double width, and heavy gauge welded galvanised steel netting securely fixed to the upper surface. The spans of the two bridges will be approx. 5.0 to 5.5 metres, precise lengths to be determined once the footings are in place. This solution is not ideal, but appeared to be the best available without constructing a major 10 metre span bridge. It does depend on the stability of the spit of land projecting from the northern bank, where Footings 2 is proposed. Currently this is protected by the roots of a small tree growing from the bank. Judicious pruning of the tree to reduce top weight may help to prevent it falling and taking the bank with it. ATTENTION: GR 0508 8685. Steps leading from the footbridge site to join CR 11 [Photo 6]. Four steps in disrepair lead up to join CR11. These to be removed, and five new steps constructed, using risers 50 x 200mm section, each 2000mm length, retained by timber pegs or posts driven into the ground. 2 to 3T stone to provide infill for the step surfaces. WATCH: GR 0508 8685: Path entrance from CR11 [Photo 7] is somewhat overgrown. Cutting back of surrounding growth and widening will help to identify the path entrance for users.</p>

Bridge and steps

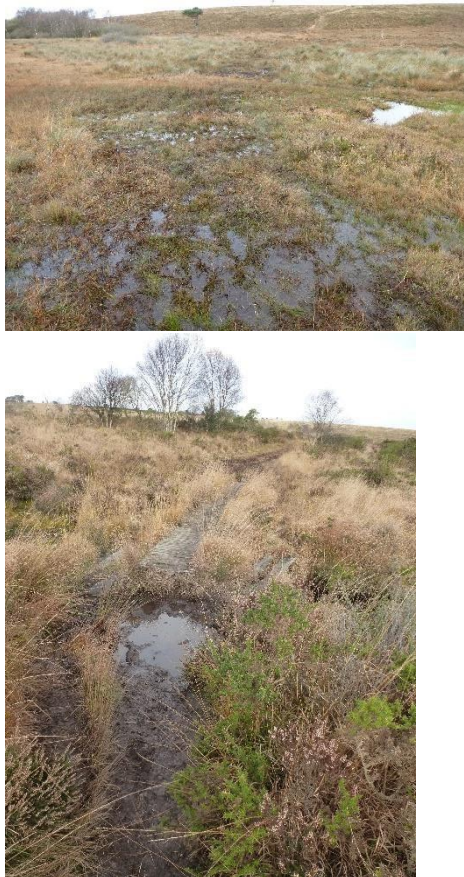
Colaton Raleigh	CR22a	<p>ATTENTION: GR 0413 8698 [Photo CR22a 1] Flooding across the width of the track. 10T stone to restore level.</p> <p>ATTENTION: GR 0413 8700 [Photos CR22a 2 & 3] The existing 10 metre boardwalk is sound, but access at either end is affected by flooding and deep mud. Infill each end with 20T stone, or extend the boardwalk by 5 metres each end.</p> <p>ATTENTION: GR 0416 8735 to GR 0426 8750 [Photos CR22a 7 to 10] 125 metre stretch which crosses several small watercourses, and when inspected was covered with water and mud throughout, to a depth of 100mm, but with a hard base beneath. Possibly the only solution would be to construct a boardwalk along the entire 125 metre length, minimum ground clearance of 200mm to allow water to flow underneath. In winter the only suitable footwear would be wellingtons. The existence of the boardwalk and sleeper bridge are evidence of attempts in the past to make this an all-weather route, but to ensure this with the construction of a further 125 metre boardwalk may not be justifiable.</p>

Remove infrastructure to discourage use. Use resources on alternative nearby routes (CR1d & CR6A)

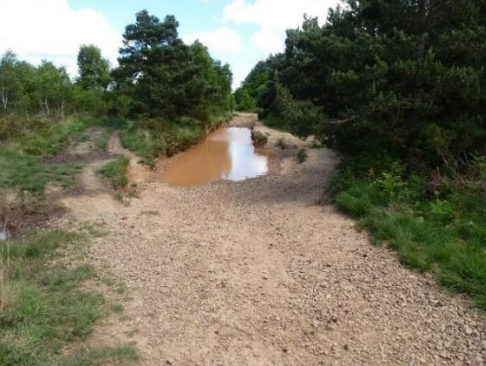
Woodbury	W17d	A	<p>Deeply flooded and damaged section for 105 metres from the northern end [photos W17d 4 to 7] Requires 100+T stone, levelled, to infill. Continuing south, at the bottom of the hill [photo W17d 3 flooding occurs after wet weather. c10T stone to raise the level and allow water runoff.</p>

<p>Reduce to 30T 40mm 40T as dug Reprofile existing material and address drainage. Heath brash</p>
Woodbury	W18a	A	<p>1). Severe damage for approx 30m, where the route starts downhill from W9 [photos W18a 1 to 4]. The route splits with a walking option either side for the length of the erosion. Solution could be to rebuild one side (eastern), to leave the other side as it is. Repairs could consist of laying c30T stone, levelled, and held in place by a series of revetments across the route using timber such as 450 x 250 cross section, to effectively create a series of four to five steps. Vehicle access required, reform and include drainage. Heath brash spread on sides to restore edges of track.</p> <p>2). 50m further south at GR 0424 8680 [Photo B18a. 4] flooding of the route has occurred at the bottom of the hill. It will be necessary to allow water to drain across the route so the solution could be EITHER to lay 20 to 30T of <u>large</u> stone, OR to construct a 5m footbridge on the western side, using two sleeper sized timbers to give a min width of 500mm, at a height above ground of not more than 700mm, which would then not require a handrail.</p>

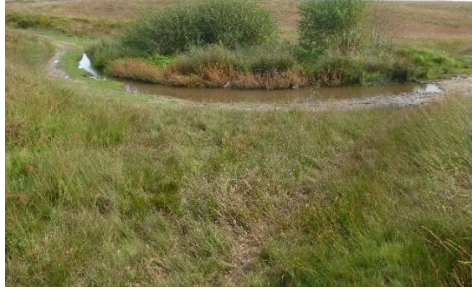
<p>WATCH GR 0413 8778 Where the track follows a 900 right-hand curve water cannot drain away on the inside of the bend, threatening flooding of the whole track. If not possible to improve drainage by cutting drainage channels, 25T stone laid and compacted would increase the track level and allow natural drainage away from the site</p>

Drain (25T tbc)
Bicton	B1a B1b		<p>Ponding over 20m. 30T stone, spread and levelled. Ponding in wet weather towards junction with B1c. 30T stone spread and levelled to fix.</p>

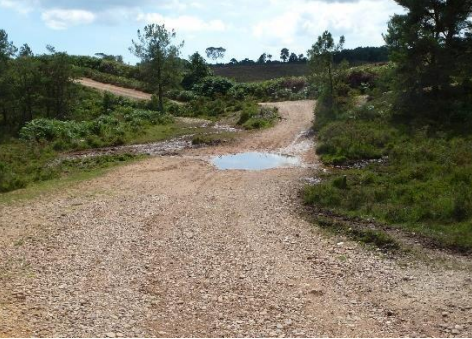
40T as dug over total section
Bicton	B1e		<p>At GR 0367 8573, at the bottom of the hill near the junction with B6d a water course crosses from the west side. After rain, water ponds across the full width of the track. It does not appear feasible to pipe the water course below the track. If a solution is required, a raised sleeper walkway on the western side of the track would provide a dry crossing. Double width sleeper size treated timbers 3400 x 255 x 90mm, covered with heavy duty mesh, minimum overall length 10 metres.</p>

10T Stone or French drain rather than boardwalk?
