Matford Centre Roof Replacement and Associated Works

Extract from the Condition Survey by PH Warr plc carried out in 2007.

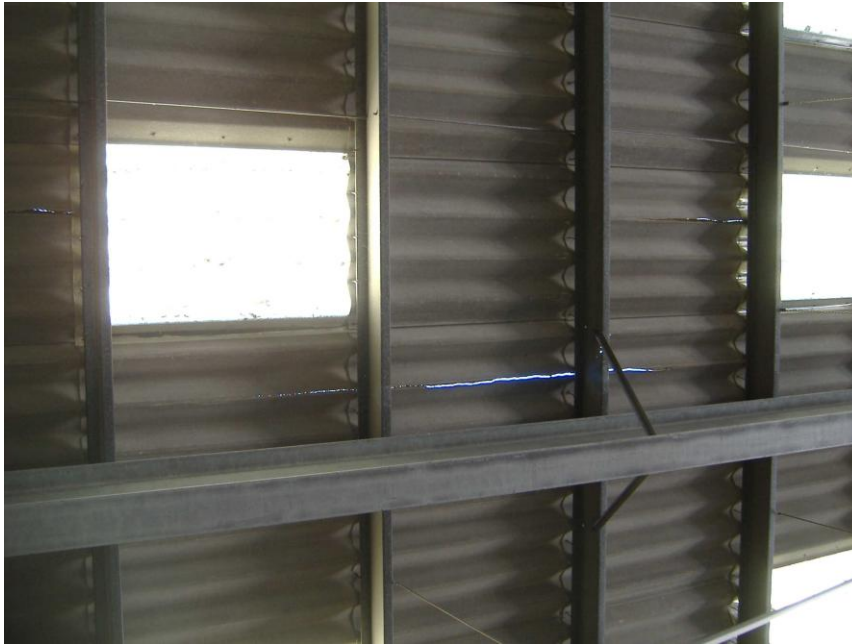
The fibre cement roofing sheets are inherently weak and brittle and have had splits and leaks in various places for many years: the 2007 condition survey stated "depending upon how much importance the Council attaches to returning the roofs into a weathertight condition, the worst of the cracked fibre cement sheets and corroding hook bolts should be repaired or renewed." It gave a total life expectancy from installation of 30 years, which equates to a replacement due in 2017-2019.

The roof has been identified as needing replacement in the next 2 to 3 years, and the current condition confirms this is a correct assessment of need. However to undertake this task once the PV has been installed, would necessitate the complete removal of all PV panelling, cabling fixing support systems, lightning conductors and man safe systems, and clearly this would incur a significant downtime for the array, a resultant loss of income, and significant extra installation costs.
