VEHICLE EXAMINATION REPORT

Report No: TOP006	Inspection Date: 15/06/2016
Customer Details Mr. T Goode 21 Venny Bridge Pinhoe Exeter Devon	Inspection Address Top Marques Pinhoe Exeter Devon EX4 8JN
Telephone: 07967 879090	Telephone: 01392 464640

Make & Model	Peugeot Expert	Registration No.	SB06NUU
Colour	Blue	Engine CC	1997(approx)
Vehicle Identity Number. (VIN No.)	VF3BARHWB86267569		Confirmed Yes
Engine No: DYSX4027834			
V5 Registration doc checked	YES	MOT Certificate Expires	14/06/2016
Odometer Reading	170776 Miles	Service Records Seen	NO

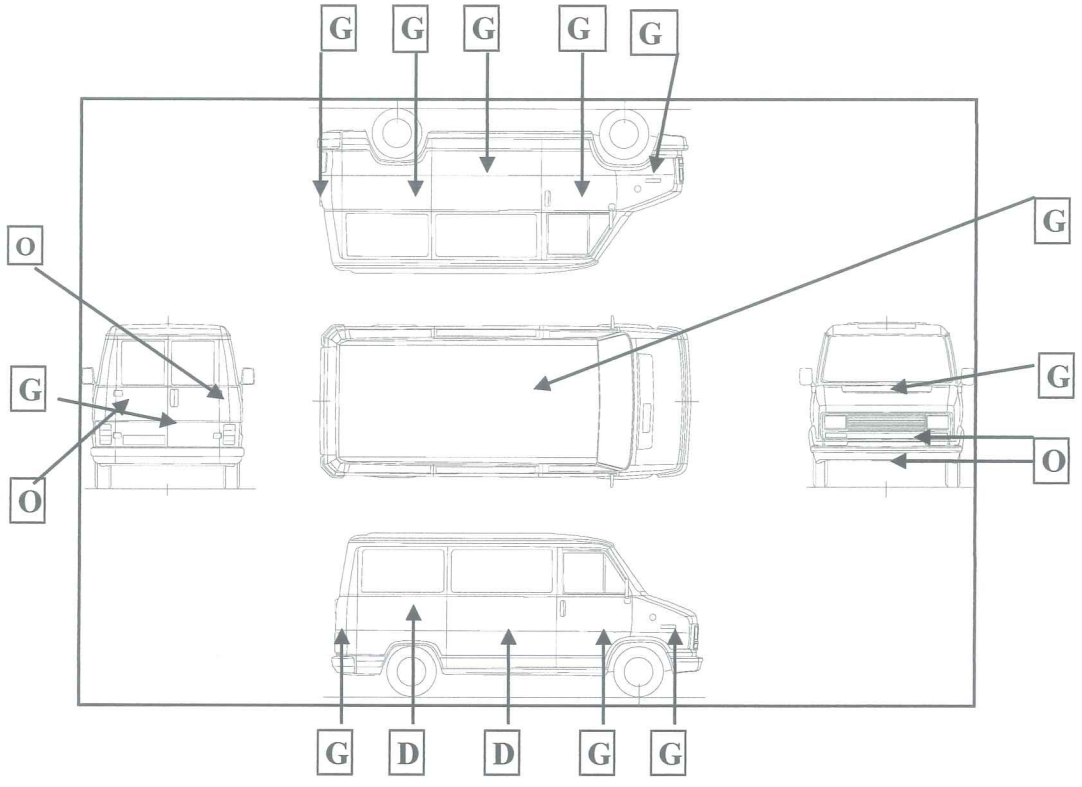
EXTERIOR PANELS

EVIDENCE OF BODYWORK REPAIRS **NO** No Major Repairs seen

Paint is peeling from around the rear door hinges
Has scuff marks on rear read and ¼ panel
