Briefing Report

Subject:	Northbrook Swimming Pool
Reason for briefing note:	To ascertain the future of Northbrook Swimming Pool
Responsible Officer:	Catherine Hill
Date:	24 th January 2025

APPENDIX G – CURRIE AND BROWN DECARBINISATION REPORT

Northbrook Swimming Pool

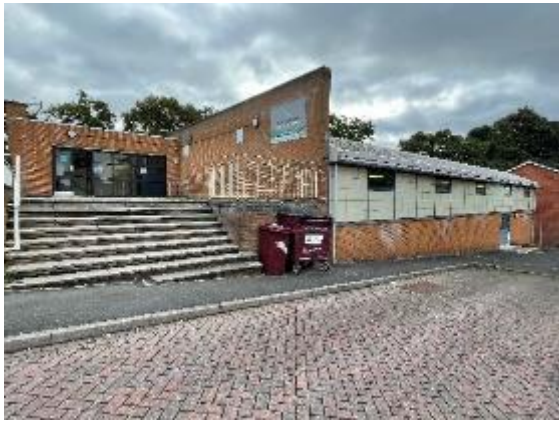
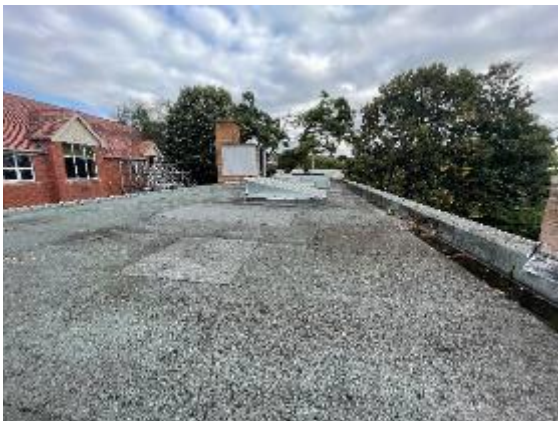
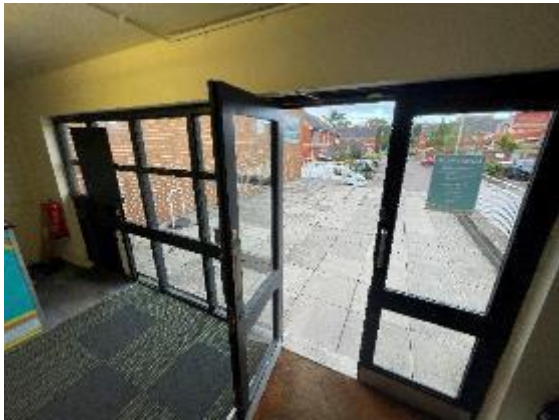
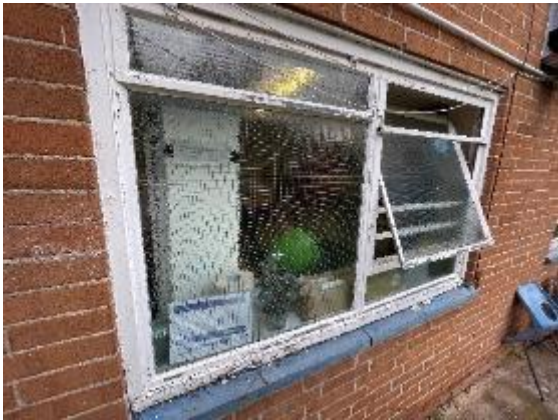
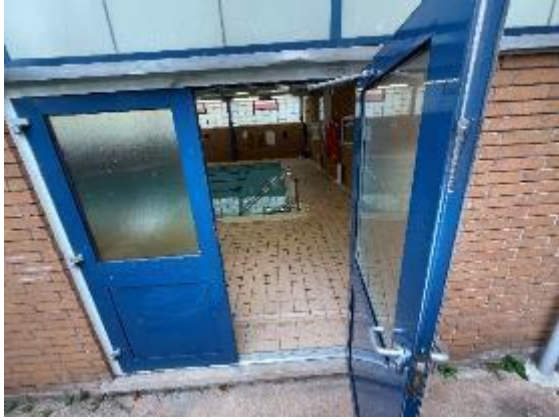
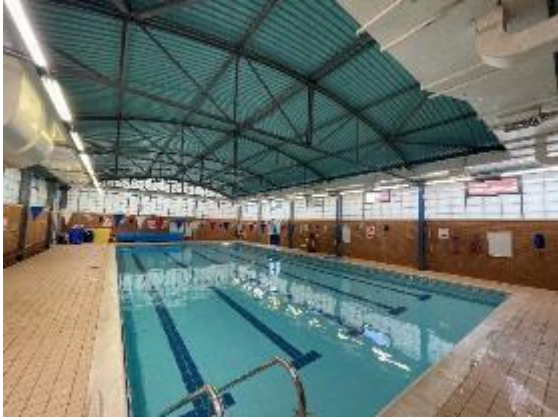
There are some localised rooflights installed within the main building areas which are single glazed, Georgian wire installations. These are in poor condition, with cracked panes and contributing to significant heat loss compared to modern alternatives.

The entrance doors are timber frame with single glazed vision panels and missing draught proofing measures. There are additional aluminium framed installations containing obscured vision panels. Generally, doors are weathered and installation resulting in increased air leakage and heat loss. External doors are of timber construction and dated in nature. Majority of doors have single glazed vision panels and are missing draught proofing measures contributing to heat loss.

It is recommended the rooflights are replaced with modern double-glazed alternatives.

It is recommended the windows are replaced with modern installations throughout. We recommended the pool areas are upgraded to triple glazing with the remaining areas upgraded to modern double glazing.

It is recommended the external doors are replaced with modern installations throughout with

integrated draught proofing measures.

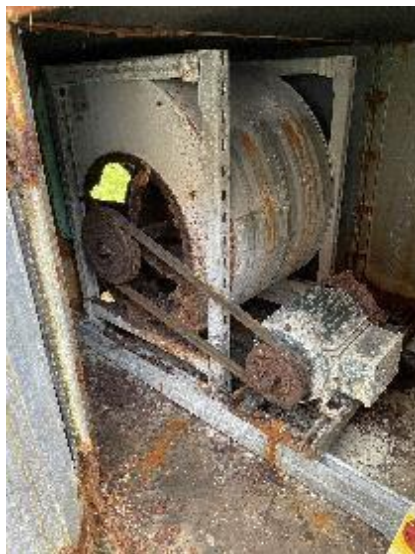
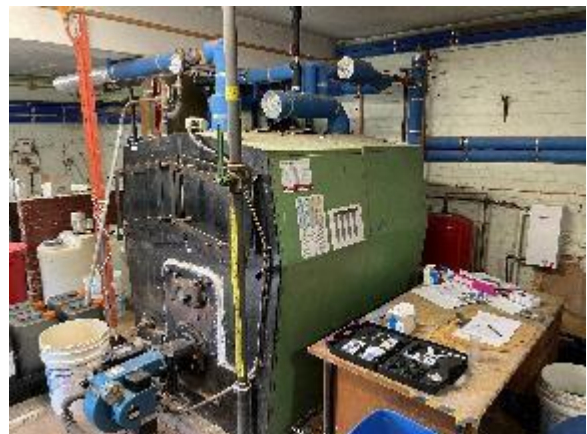
The central heating is supplied via a single 205kW Robin hood boiler that has been reconfigured in 1986 to include a gas burner. The heating within the pool space is supplied by an external Moducel AHU with a gas heater that has up to 55kW capability. The boilers supply wall mounted radiators around the building, domestic hot water calorifier and swimming pool.

The boiler is an old Beeston robin hood boiler with no plate to identify the year of manufacture or initial set up of the boiler. Beeston boilers have been insolvent since 1976, so assumed this boiler is in excess of 47 years old with the Nuway Natural Gas Burner being installed in 1986. The heat generators are life expired, in a poor condition and in need of replacement. The systems within the plant room are generally in a poor condition and need numerous rectifications.

The age of the AHU is a minimum of 14 years old, based on the Powrmatic gas burner manufacture year of 2009. Upon inspection of the unit one of the fans is completely corroded through, no lights are visible despite the unit being in operation and is generally in an unacceptable condition. There is a fan within the plantroom that appears to be a replacement for the one corroded through, however the council have suggested this has been there for years. This unit, as a minimum, needs fans to be replaced and the gas burner replaced with a low carbon alternative.

The age and condition of the existing fossil fuel heating system means it is economically viable to replace in the short-term due to being end of life.

It is proposed to replace the current gas-fired boiler for heating to a refrigerant based heat pump equivalent, including the replacement of emitters with larger low temperature radiators suitable for heat pumps which produce a lower flow temperature.

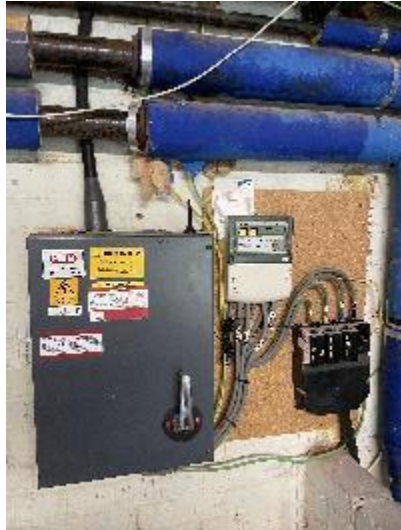
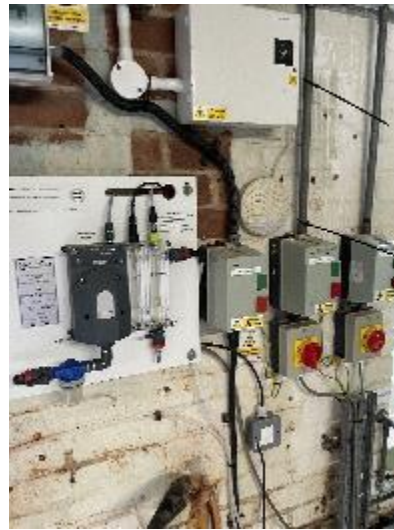
The main incoming electrical supply and distribution is in a satisfactory condition.

A request for information has been submitted with the DNO regarding site upgrade, based on the current allowances it is likely that an upgrade in supply will be required. This is TBC upon the DNO providing further information.

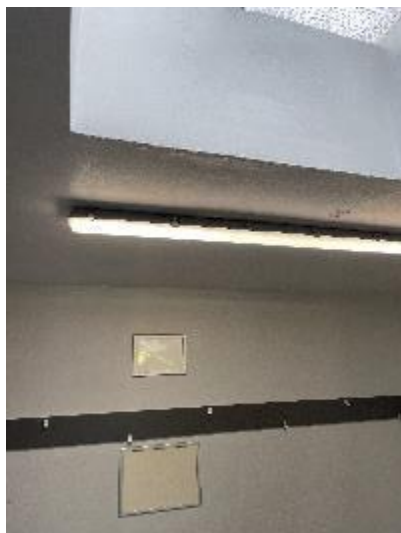
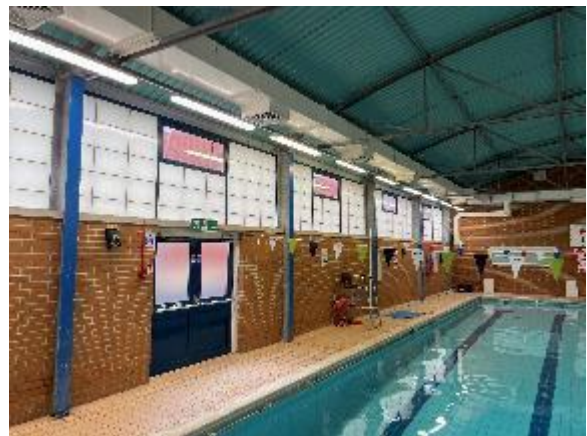
Lighting is a fluorescent throughout the building and would benefit from being upgraded to LED throughout.

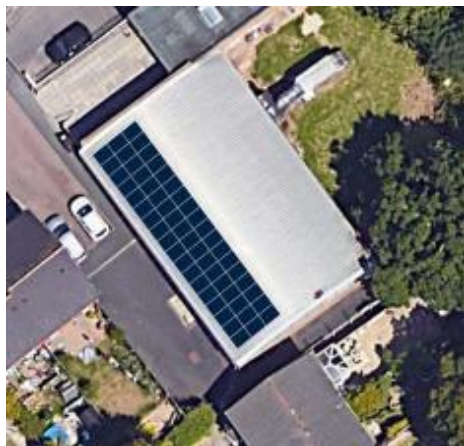
PV arrangement for Northbrook Swimming Pool

This survey was conducted remotely based on site information and was deemed to be safe for the installation of PV. Due to the age and nature of the building and surrounding area conservation consent maybe required for the installation of PV.

For G99 and district network operator (DNO) considerations, there shall be local voltage and frequency control for export to the grid in moments of excess power generation. A G99 application will need to be completed as part of the installation process by the DNO.
