EXETER CITY COUNCIL
SOUTH WEST WATER LIAISON GROUP

Tuesday 9 July 2013

OPERATIONAL UPDATE

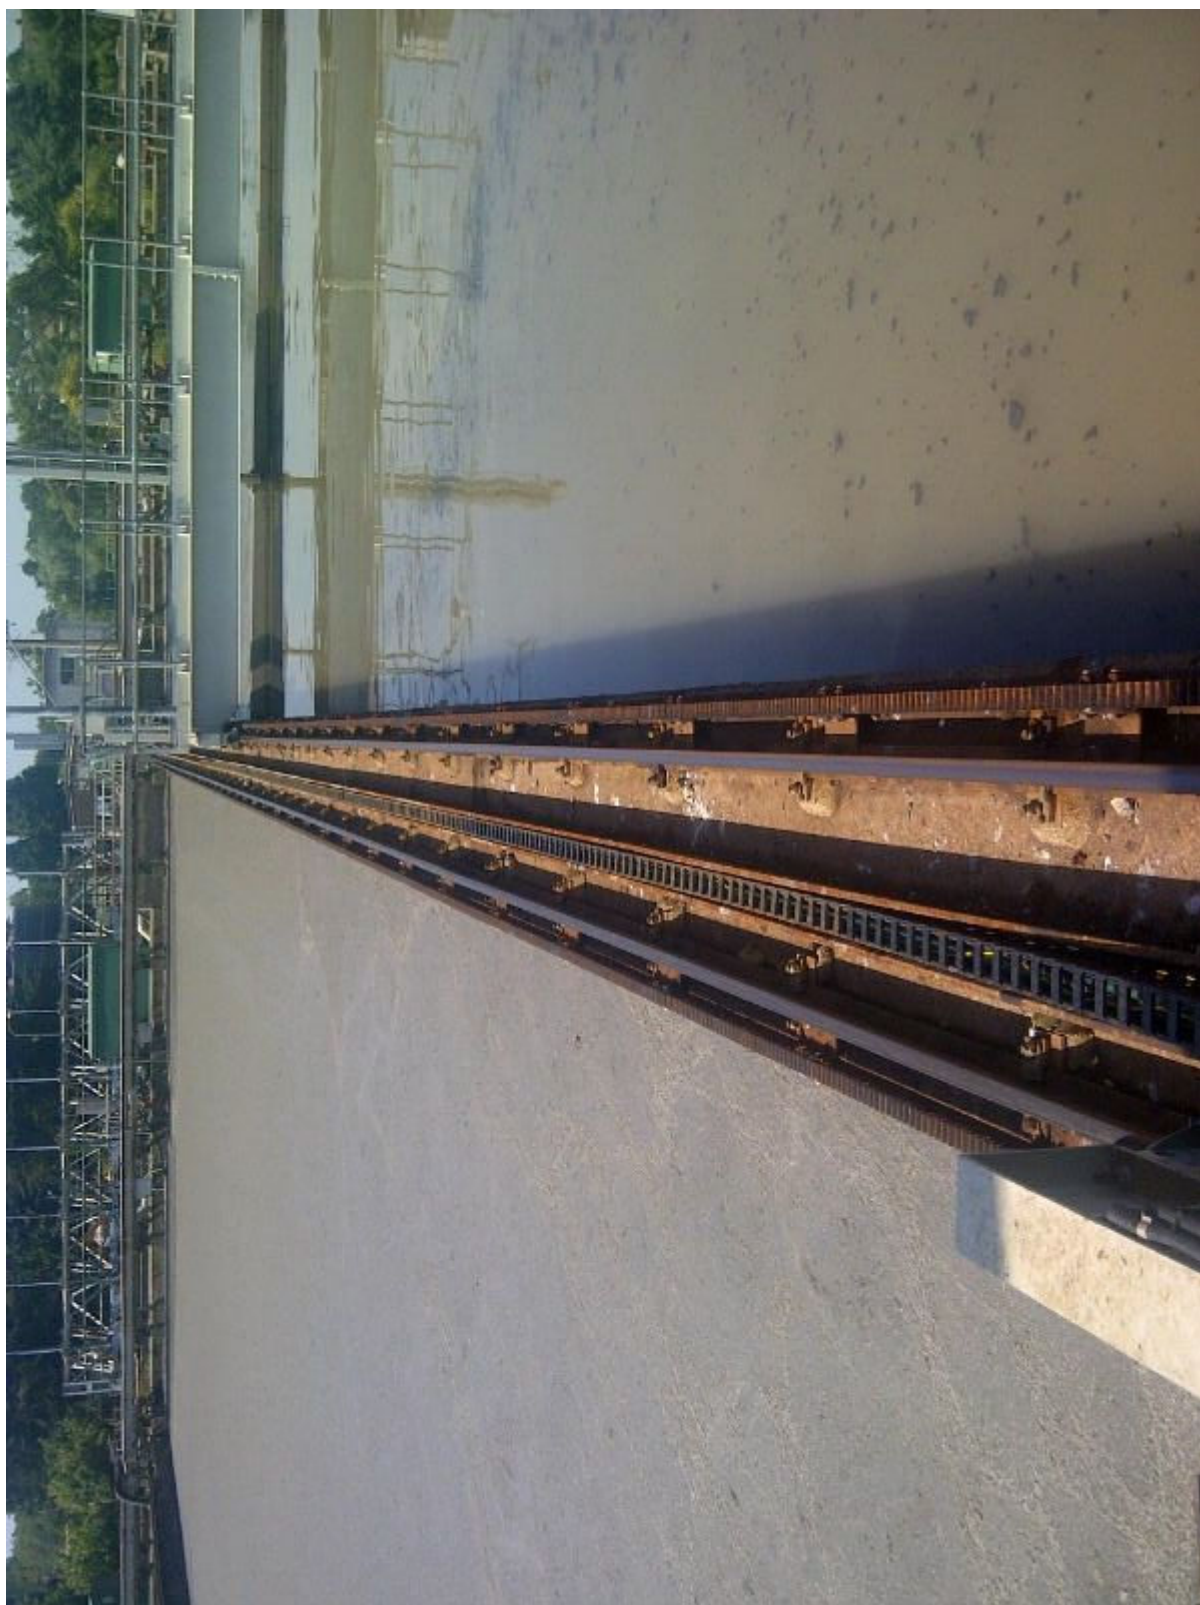
- Photo 1 showed two of the primary tanks. The tank on the right hand side of the picture was how the tank should look, with the tank on the left hand side showing sludge on the top which was the cause of the odour as it cannot be taken out of the tank quick enough. When working to full capacity, the scrapers will scrape the tanks every hour.

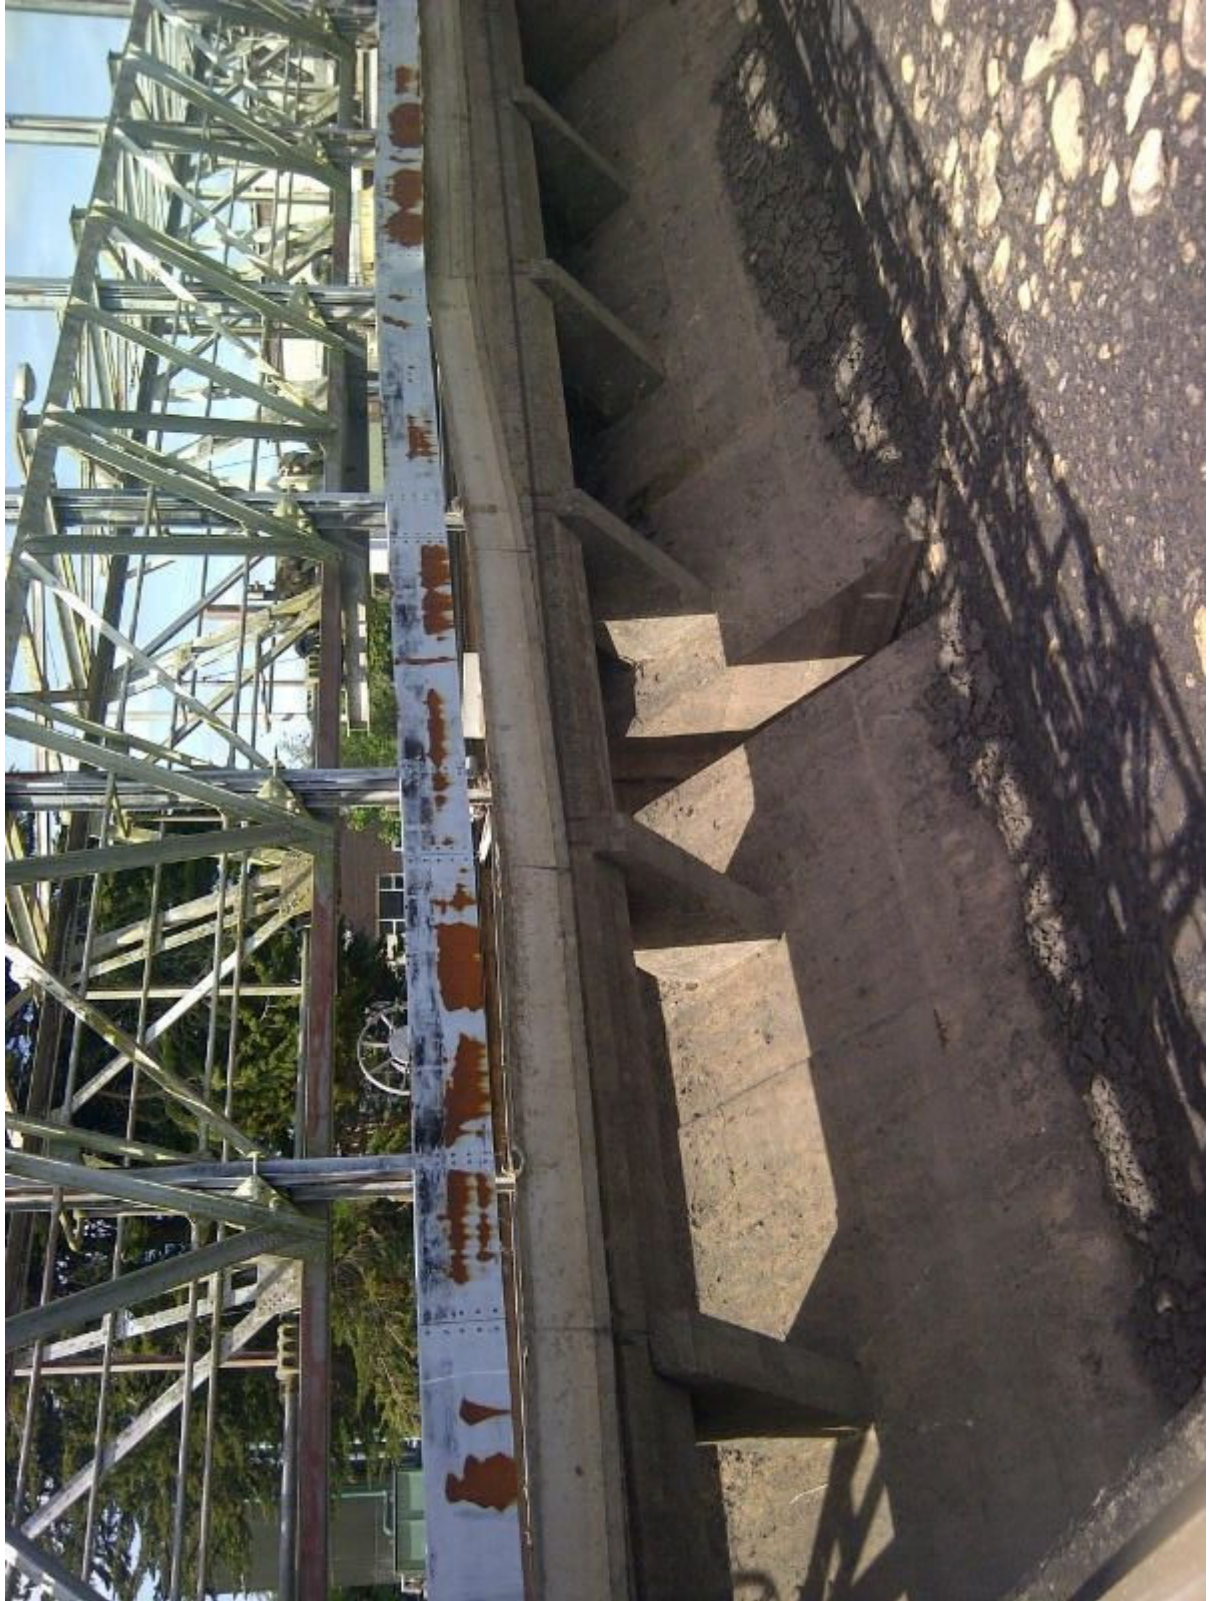
- Photo 2 shows the storm tank scraper which is twisted in the centre. The residue of sludge can be seen in the tank.
- Photo 3 is a photo of sludge drying out. In the event of rainfall, this will fill up and create more residue on the floor again. This will give off a background odour.

In addition, there was also a problem with the storm tanks. The scraper had been reliable up until the last two months but had now twisted and was out of action. Work was currently being undertaken to ascertain if a temporary repair can be done. There is sludge remaining in the tanks and this is giving off odours.

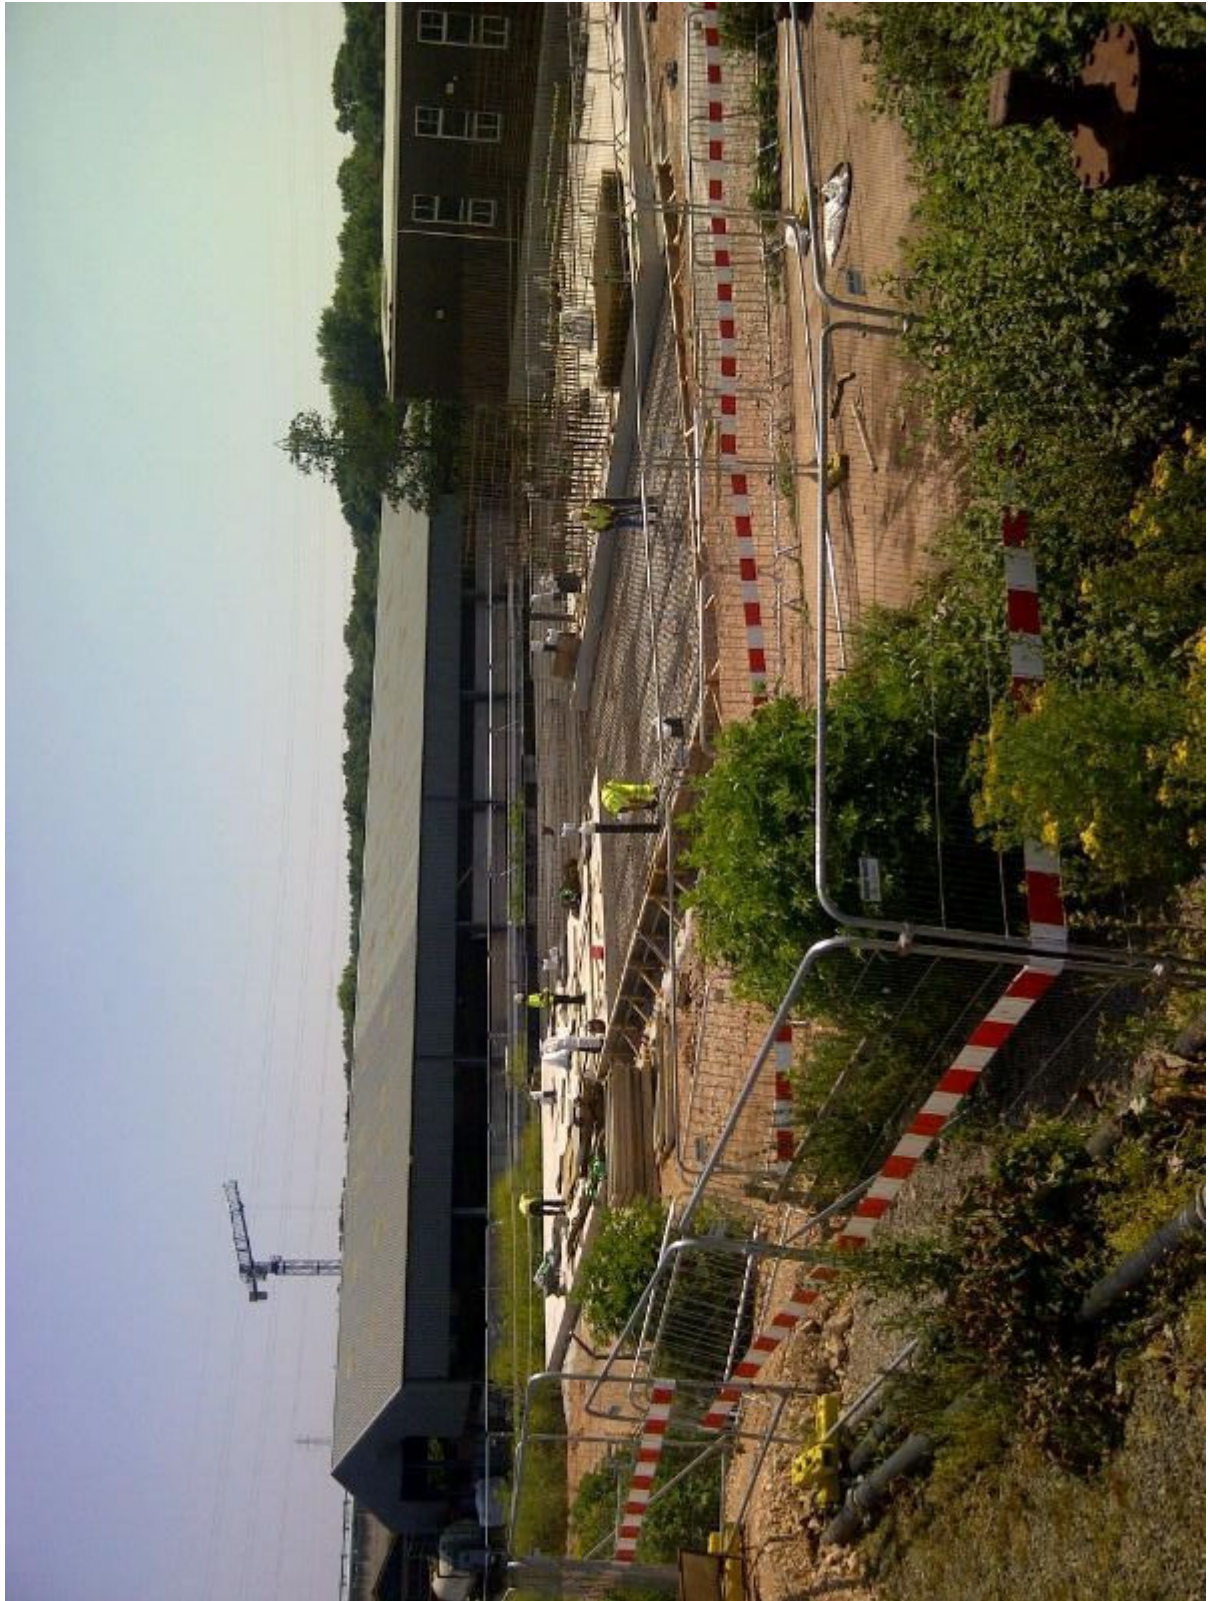
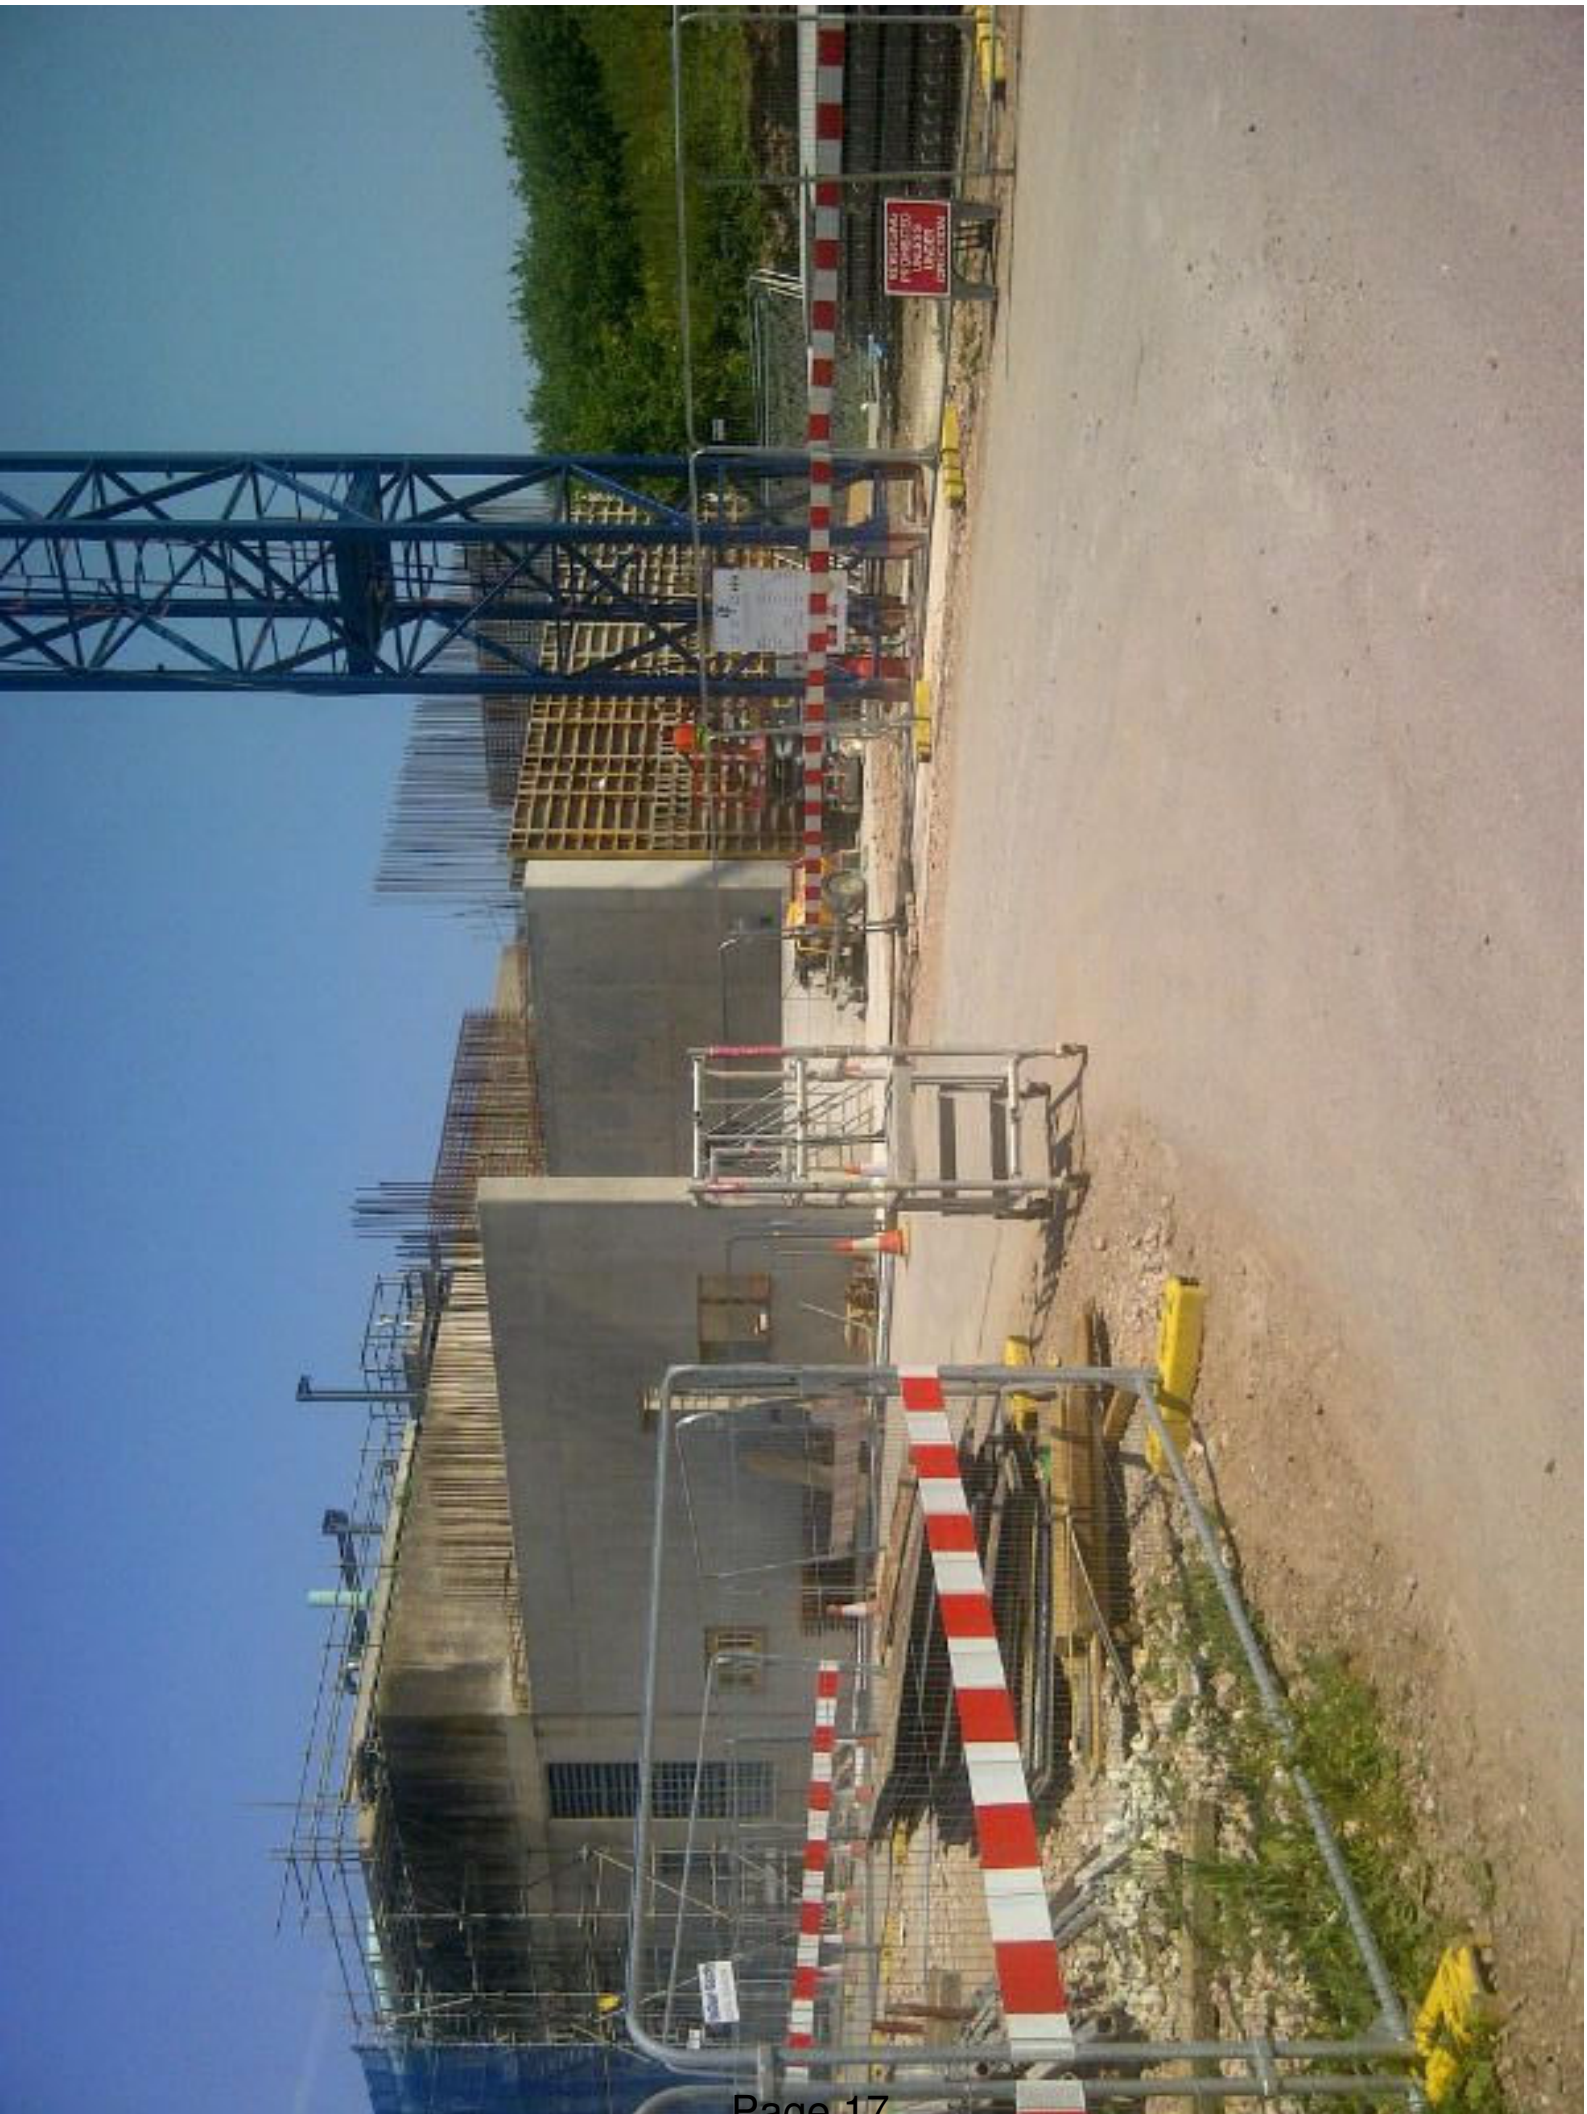
- Photos 6 and 7 shows construction work on site for a new sludge centre and additional Biological Aerated Flooded Filter (BAFF) plant, which will take 6-12 months to build.

A supply and demand study had been undertaken for the future catchment area in terms of additional developments in the city. In order to cope with future development and the expansion of population, an additional Biological Aerated Flooded Filter (BAFF) would be also be built taking the total from five up to six.
