1. List of Sites Vulnerable to Incursion

3. Design Considerations

Anti-Incursion Measures Available

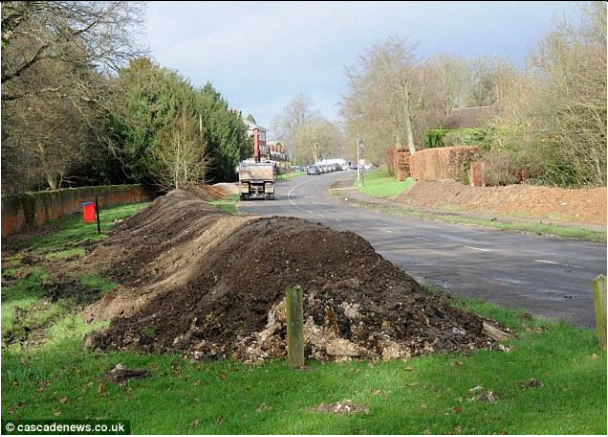
Measure	Pros	Cons	Est. Cost	Example Photo
Bund (could include ditch)	Low Cost. Low carbon option if material on-site. Preserves limited pedestrian access.	Visually obtrusive due to height, exacerbated if not turfed (see example photo). Susceptible to erosion in well-trodden areas which reduces protection.	£15/metre (£25/metre if turfed afterwards)

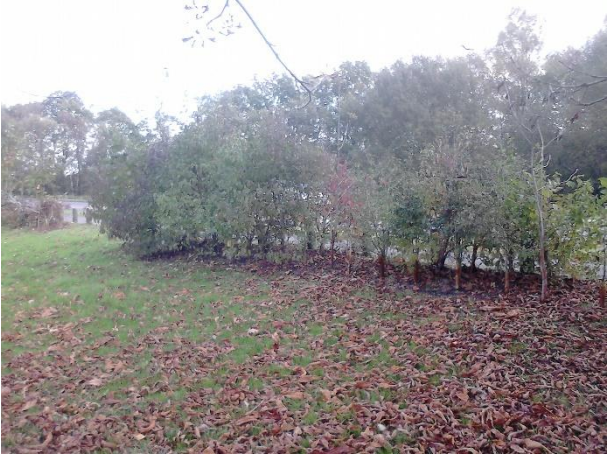
Tree & Hedge Planting	Low Cost Low Carbon Environmental Benefits (habitat creation, air quality improvements) Can easily follow natural topography	Takes time to establish, risk of damage whilst new. Risk reduced using established plants. Maintenance costs associated with hedge cutting. Potential to exacerbate anti-social behaviour if large areas with no overlooking are created.	£20/metre if using small whips, £50/metre for established plants

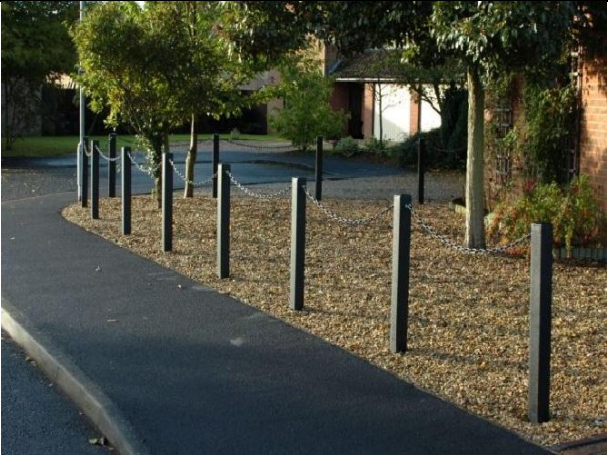
Post / post & chain	Lower carbon costs can be achieved through use of recycled materials. Long life span. If posts only, boundary remains porous to pedestrians and cyclists.	Susceptible to being hit by vehicles and damage through mis-use resulting in additional maintenance costs. Chains present a trip hazard to park users trying to cross them.	£35/metre - £75/metre

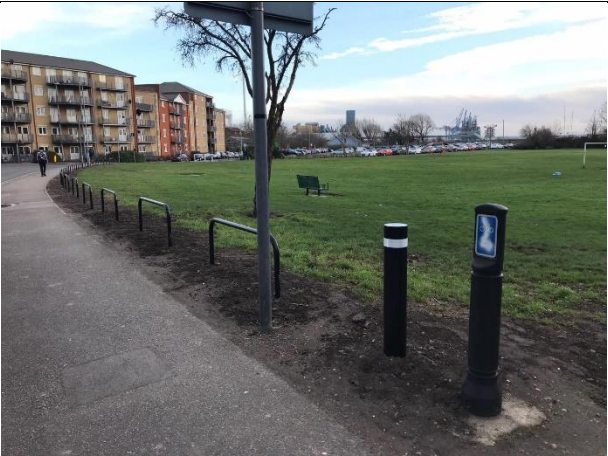
Steel Barriers	Variety of styles available, can be selected to match character of POS, minimising visual impact. Fencing can alternate to reduce cost and to maximise permeability for legitimate park users.	Low-level fencing can create trip and vehicle collision hazards. Some fencing arrangements can limit access for legitimate site users. Painted barriers need to be maintained, labour intensive job to re-paint long lengths	£50/metre - £150/metre (varies based on spacing between panels)

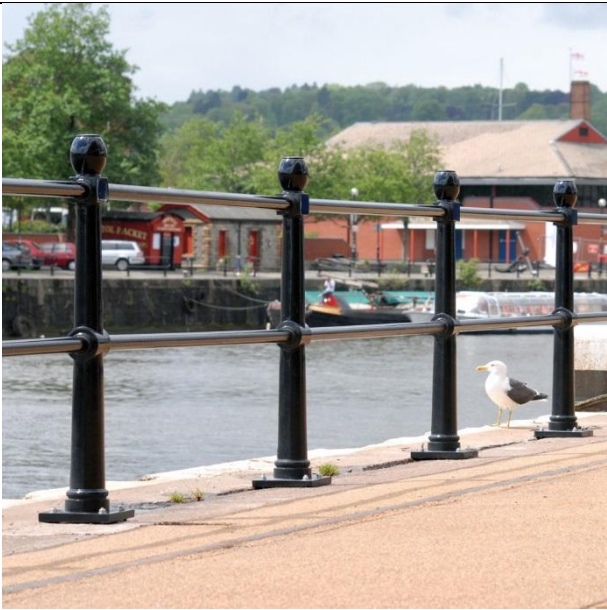
Steel Post & Rail Fencing	Variety of styles available, can be selected to match character of POS.	Limits permeability of site boundaries to formal openings. Painted fencing needs to be maintained, labour intensive job to re-paint long lengths	£200/metre

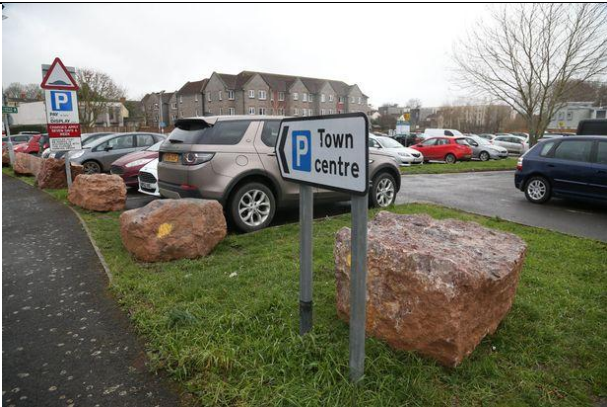
Boulders	Natural looking. Low carbon cost Provide some limited play / seating value. Tamper proof. Very difficult to move or damage.	Availability based on quarry blasting regime. Expensive to move once placed.	£250/metre

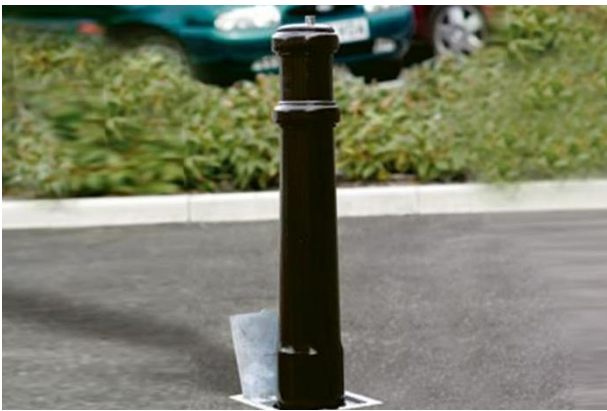
Measure	Pros	Cons	Est. Cost	
Lockable Droppable/ Removable Bollards	Permits free movement of cyclists and pedestrians.	Susceptible to being hit by vehicles resulting in additional maintenance costs. Some versions are locked by padlocks, easy to break to gain entry. Others need a key which will need to be provided to external contractors to gain access.	£400/ea

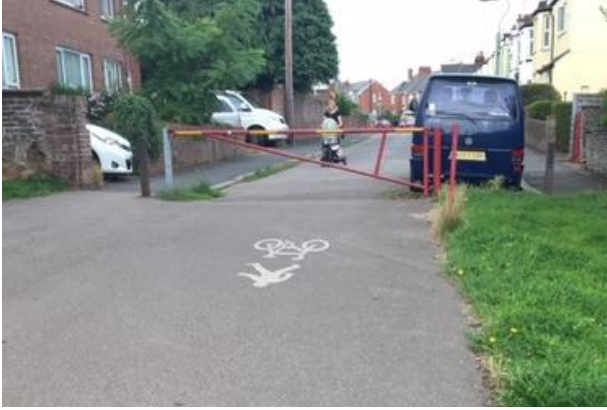
Lockable Steel Gates	Provides visible obstruction to access, may provide a low level of deterrence.	Typically locked by padlock, these can be easily broken to permit access. Provides obstruction to cyclists, can obstruct pedestrians.	£2,000/ea

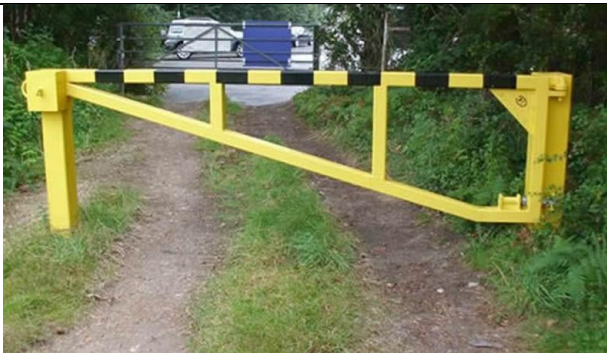
Tamper-proof steel gate	Provides visible obstruction to access. Locks are either tamper-proof, or else padlocks are shielded to make it hard to break in.	Tamper-proof locks require more frequent maintenance, specialist component makes this relatively expensive.	£3,000/ea

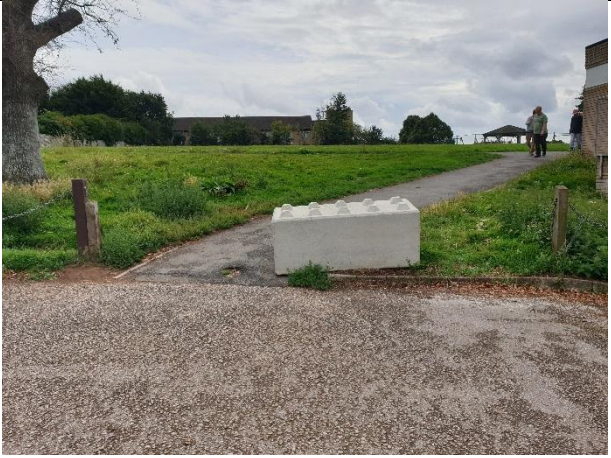
Concrete Blocks	<p>Low Cost Option.</p> <p>Permits free movement of cyclists and pedestrians.</p>	<p>Visually obtrusive, though could be mitigated through painting etc.</p> <p>Difficult for permitted access as needs to be moved by excavator or similar.</p> <p>Can be dragged away by powerful car or van, needs to be used in combination with other measures</p>	£150/ea

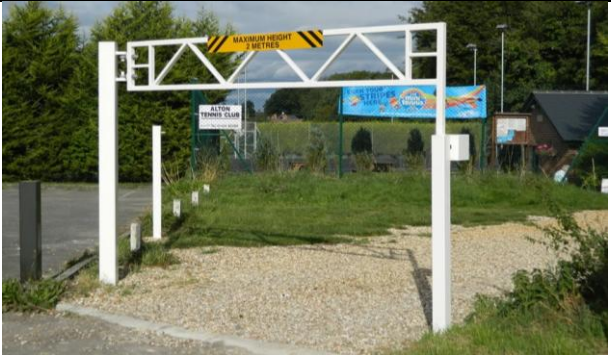
Height Barrier	<p>Permits free movement of pedestrians and cyclists.</p> <p>Allows free movement of smaller cars into the site.</p> <p>Maintains access for tractors and other large vehicles when opened.</p>	<p>Some designs still susceptible to padlocks being cut.</p> <p>Will inconvenience legitimate site users who may drive vehicles above the height limit.</p>	£4,000/ea

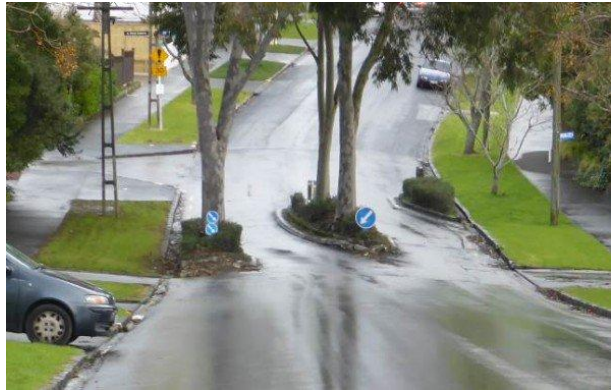
Highway Modifications (e.g. Chicane)	<p>Most versions are tamper-proof, can't be damaged to gain access (bollards are the exception).</p> <p>Can be designed to limit visual impact or even improve look of site entrance</p>	<p>Difficult to both prevent unwanted access whilst preserving an access for maintenance and emergency vehicles.</p> <p>Bollards etc. used to remove turning circle are liable to be hit resulting in replacement costs and potential claims.</p> <p>Typically a very expensive option.</p>	Location Specific
